VIVA BUS DEPOT

Five Star RS Anchor Gel
Five Star Structural Concrete

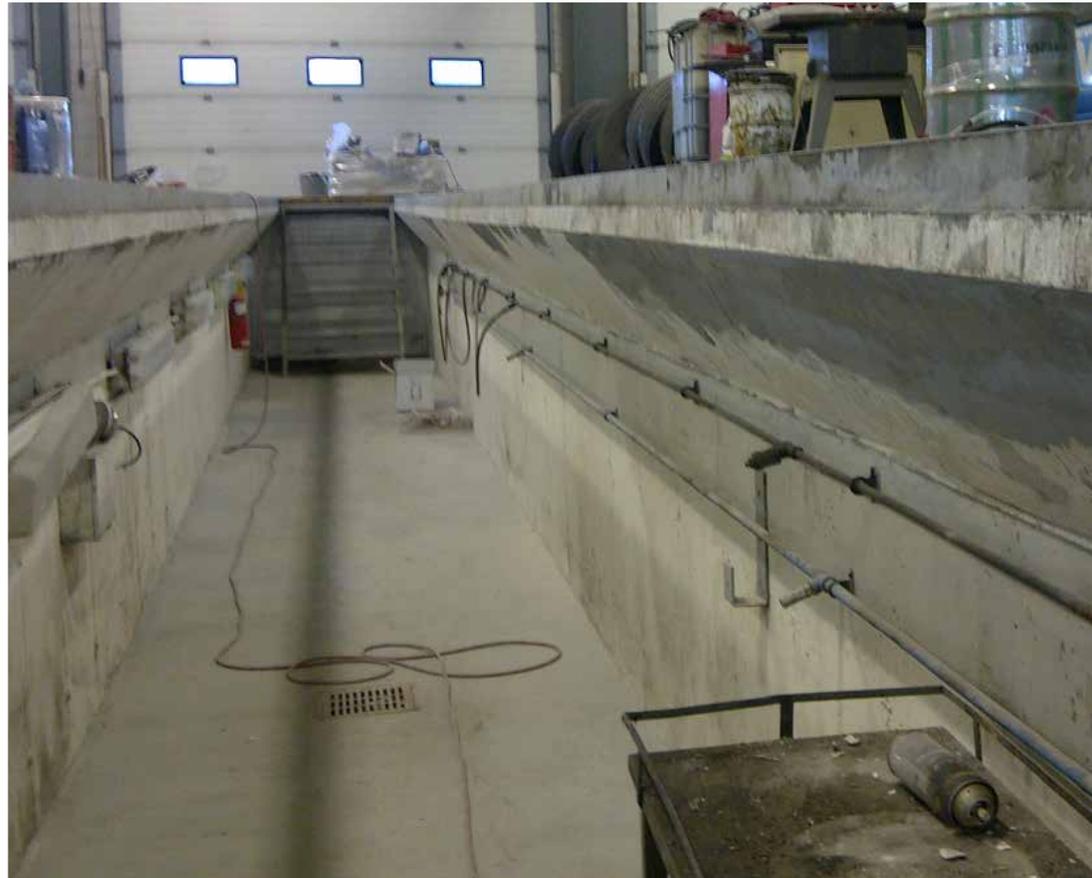
Repair the extensive mechanical damage to the inspection pits caused by impact from “bendy buses”.

Damaged concrete was broken out and then Five Star RS Anchor Gel, known for its rapid setting and excellent adhesion properties, was used to secure reinforcing mesh. Formwork was erected around the repair and Five Star Structural Concrete was used for concrete repairs. Five Star Structural Concrete was applied by the form and pour method.
